Assessment of photovoltaic pumping systems in Thailand – one decade experience

Abstract

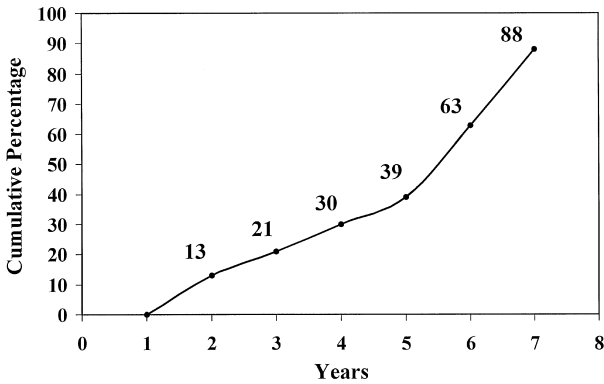
Fig. 2. Cumulative percentage of broken PV water pumping units in relation to number of years after installation.

Results indicate that up to 40% of the units would fail after 4 years of installation. The failure rate increased markedly after this. An average lifetime of a unit would be less than 8 years if there is no intervening and repair mechanism. Fig. 2 illustrates the situation.

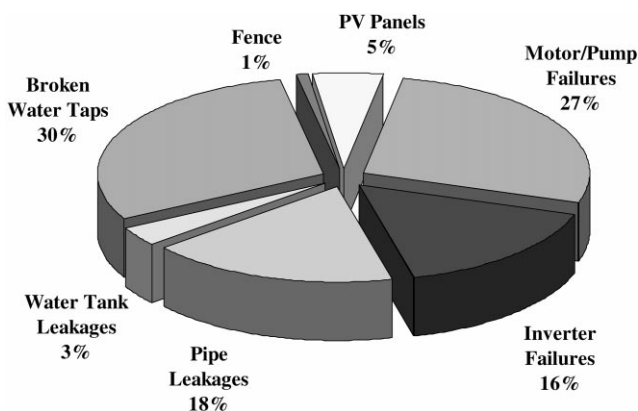
Fig. 3. Sources of failures and damages of PV water pumping units from 1996 to 1998 survey (489 sites).

In 1996, we reported results of an initial survey, indicating that most failures were due to inverter breakdown (10%) and motor-pump breakdown (23%). The remaining were structural problems, leakages and drying of water sources. Motor-pump failures are closely related to poor water quality and lack of simple maintenances to prevent algae, water plants and sediments from blocking pipes and pumps. Inverter failures occur from surge during lightnings, inadequate protection from moisture and temperature build up. Insect nesting in inverters can also cause short-circuiting.

After completing the 3-year survey a worsening situation emerged. Now over half of the failures are caused by inverter failures (19%) and motor-pump failures (32%) (Fig. 3). While the former could not have been rectified by villagers, the latter could have been reduced by training and proper management by villagers.
