## **The Inner Area Change Detection in Pak Panang Bay Before and After the Operation of the *Uthokawiphatprasit* Watergate using Aerial Photographs and Geographic Information System**

### **ABSTRACT**

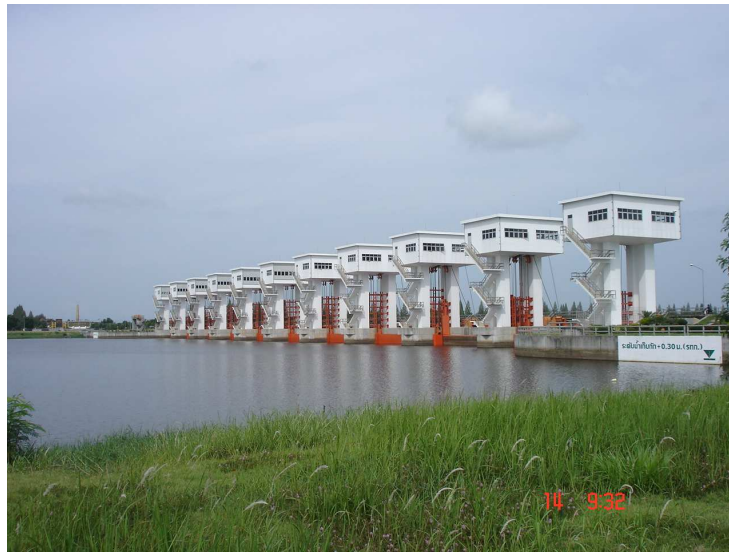
**Figure 2.** The *Uthokawiphatprasit* Watergate.

In October 1999, the *Uthokwiphatprasit* Watergate began its operation over the Pak Panang River in order to prevent salt-water intrusion into the inner area along the river and to keep fresh water for mainly agricultural purposes (**Figure 2**). Since then, debates over the pros and cons of the watergate in operation have been raised many times. A main area of debate is sediment reduction due to the watergate and calls for investigation. The objective of this research project is to examine changes in the coastal area in the inner Pak Panang Bay before and after the operation of the *Uthokwiphatprasit* Watergate by using a combination of aerial photographs and geographic information system techniques.

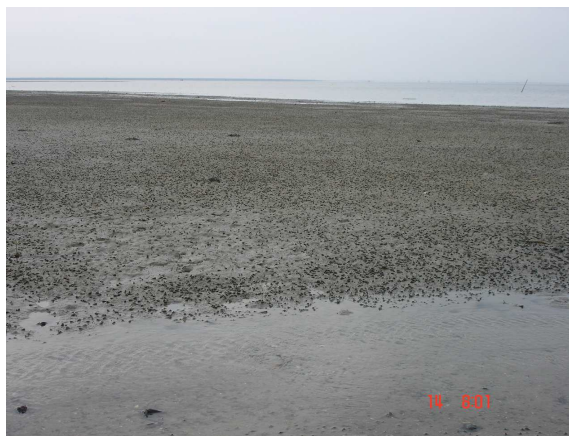
**Figure 4.** Area of sediment deposition.

The reduction of sediments from Pak Panang River deposited in the bay might benefit the Pak Panang Bay not only by delaying the sediments filling up the bay but also by reducing the navigation channel dredging through the bay to the river. Without the watergate, the natural process of accumulation of sediments guaranteed that the progressive shoaling would continue, and that mangroves would colonize the intertidal areas, and encroach on the bay. Eventually the entire bay would fill in except for the present channel, which would become the river (1). However, debate over the watergate as the main factor of sediment reduction has been doubted, indeed the watergate might accelerate filling of the bay and shallow the navigation channel (4). The watergate in operation caused stagnation of water in the bay, which led to an accelerated rate of sediment deposition and also caused the waterways to be silted up or clogged up by Water Hyacinth weed (5). Moreover, the stagnation of water in the bay might be inducing more deposition of sand along the east coast of Laem Thalumpuk. As a result, Laem Thalumpuk shoreline would increase in length and extend its curved shape due to the influence of strong winds and currents from the Gulf of Thailand. The more curving its shape becomes, the narrower the entrance to the bay (4). However, this study has found little change in the Laem Thalumpuk shoreline in terms of extension and its curving shape between 1995 and 2003. This assumption has thus called for further investigation over a longer monitoring time period.
