## EFFECT OF MACHINE DESIGN ON PERFORMANCE OF ORIGINAL EUCALYPTUS BARK CRUSHING MACHINE

*In Thailand, eucalyptus is used widely in pulp and paper industry since it grows fast and withstands a harsh and arid environment. Eucalyptus bark, the waste material, is used as a source of renewable energy by crushing it to smaller and shorter lengths. Then, the crushed bark is transferred to the next stage of energy production. As a renewable bio-fuel, eucalyptus bark has a low environmental footprint and low production cost. But the machinery used is a crushing device which is subjected to continuous loading and thus subjected to high levels of failure. In this study, analysis of the design of the crushing machine is conducted together with the determination of predicted failure levels, nature of failure which is wear of the active surfaces, hardness measurements, and microstructural observation using SEM. After that, recommendations for design improvement are proposed.*

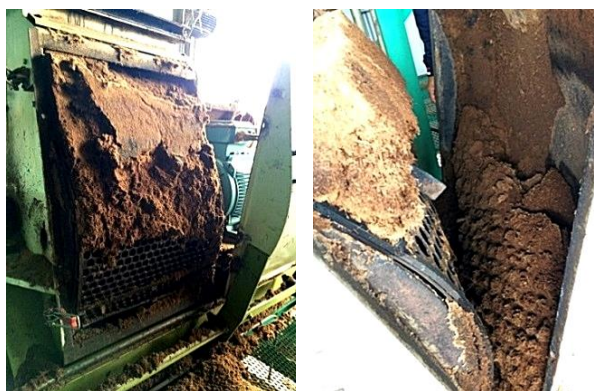
According to the design of the crushing machine, spacing between the filter screen and the cover is 50 mm. This is too narrow and allows the mix of moist, dry and sticky bark to clog at the arm of the screen-locking set, so the leftover bark between filter screen and the cover blocks. Additionally, the door-sliding guides obstruct the flow of crushed bark to the lower conveyor belt. This is shown in Fig. 5. Since the crushed bark is compacted and cannot move away, it compacts further to the inside of the crushing chamber, obstructing the motor and causing the motor to overload and trip and the machine to stop.

**Figure 5** Jamming of crushed bark between the screen and the cover

- 2) Changing or modification to the spacing between the cover and the screen is difficult. Thus a force-draft system is suggested to prevent jamming and smoothing the flow of crushed bark to the lower conveyor belt.

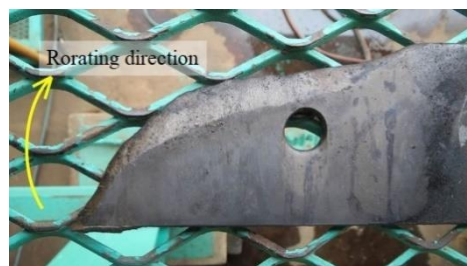
According to Fig. 3, since the longitudinal direction of the screw conveyor and the main shaft is parallel, most of the coarse bark drops on one side of the machine (section 1 and 2). Visual inspection shows a difference degree of wear, as seen in Fig. 6. The abrasive direction is related to the direction of rotation of the main shaft (Fig. 10). On the section with larger material drops on, severe abrasive wear is clearly seen. On the other side with lower material drops, slight delamination of the weld and minor wear is observed, as seen in Fig. 11. Although blades in section 3 to 6 crush the eucalyptus bark less than those in section 1 and 2, wear or the blades still be observed. A possible factor accelerating the abrasive wear of the crushing blades is congestion of crushed bark inside the crushing chamber. Another possibility is that small crushed particles become stuck between the supports and crushing blades, therefore the blades cannot rotate freely causing abrasive wear.

**Figure 10** Corresponding abrasive directions with shaft rotating direction.

As shown earlier in Fig. 4 that each support of the blades is divided into 6 sections, with 3 blades/section. Section 1 has the most severe wear (Fig. 10), while section 6 has minimum (Fig. 11). Within each section, three blades have different degrees of wear as seen in Fig. 12. Blade No. 1-1 has a higher level of wear with a knife-like shape, while blade No. 1-3 has lower wear rate and consequently has a blunt shape with one cut corner. The difference of shape of these two blades is believed to be primarily due to the feeding system feeding material to blade No. 1-1 more than blade No. 1-3. In case of blade No. 1-2, located between blade No. 1-1 and 1-3, with minimum spacing (60mm) made blade No. 1-1 and 1-3 as shields that protect blade No. 1-2 from direct contact with the bark. Therefore, a very small amount of weld delamination and wear was observed. In section 6, at the furthest end of travel of screw conveyor, very light wear was observed. This was due to the feeding system spreading the material to the first and second section in preference to the others. Once severe wear occurs, all 144 blades have to be changed, wasting spare parts, time and energy production.

- 1) The feeding system of coarse bark should be modified to distribute the material to the crushing chamber evenly. In this case, all 144 blades will experience an even wear rate. Furthermore, it is suggested to oscillate the direction of rotation, so that both sides of the crushing blades have a similar wear rate. By doing this, the service life of the crushing machine will be enhanced.

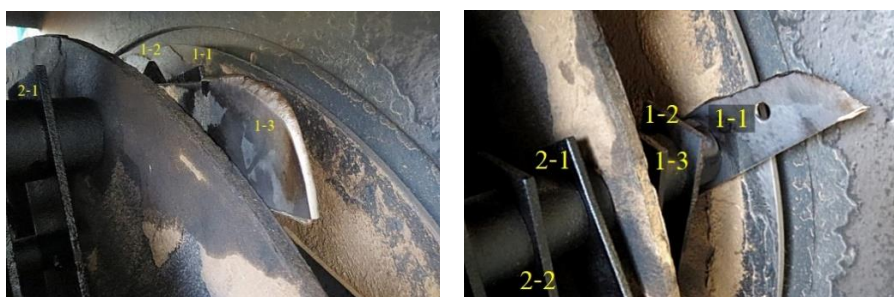
**Figure 12** different level of wear in a section

- 4) Since changing or modification of the arrangement of the crushing blade is difficult, changing its material to a higher hardness and toughness will be beneficial.
