INTERPOSITION OF ALIEN STRUCTURE IN AESTHETIC VALUE OF AYUTHAYA HISTORICAL
AND ARCHAEOLOGICAL RUIN

Bundit Pradabsook^{1*}, Kasem Chunkao¹ and Surat Bualert¹

¹ College of Environment, Kasetsart University, Bangkok 10900, Thailand

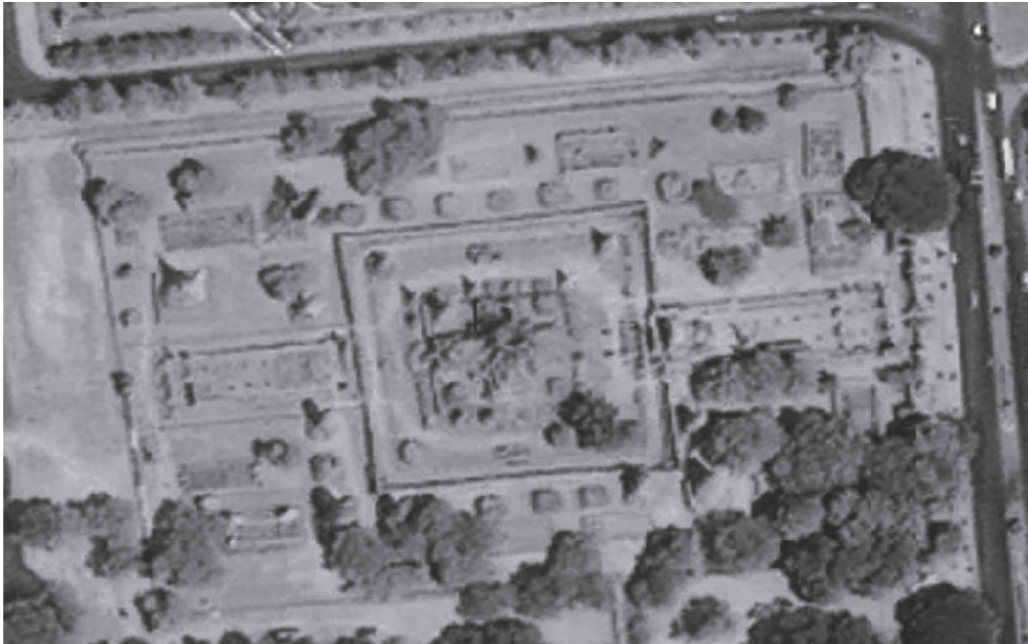
(b) Lay-out

Figure 1 Location and Lay-out of Wat Mahathart

The study site was Wat Mahathrat in the city of Ayuthaya, located on Shegun Road (Figure 1). The study area was 130 X 249 m. with high potentials not only as historical ruin but also aesthetic value for tourist site, but interrupted by the telecommunication tower. It is noted that the scope of the research was only in historical ruins of Ayuthaya, the outside historical ruins were neglected.
